Navajo Abandoned Uranium Mine

Site Screen Report

Crownpoint South Trend AUM Site

March 2010

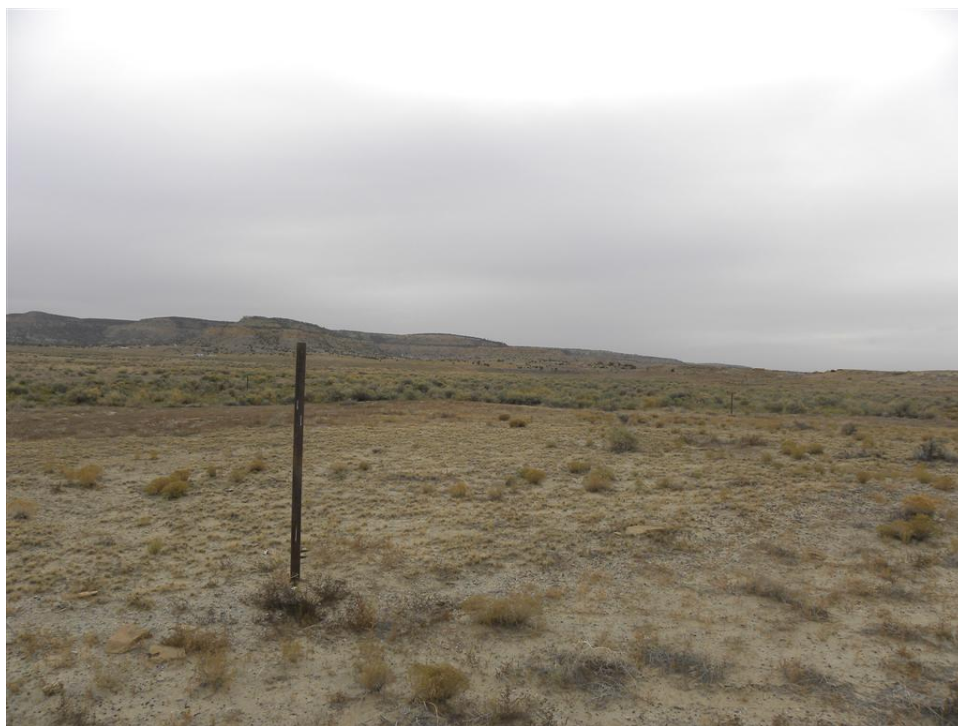
A small formerly fenced in area was found north of site #1019

Photo 9. Formerly fenced in area north mine site #1019
